# Kodiak - Pier III Replacement

# **Pier 3 Replacement**

# **1.0 Introduction**

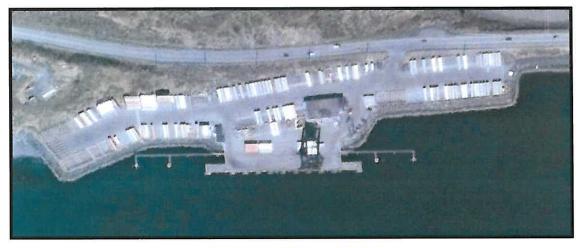
Figure 4: Aerial View of Pier 3

Pier 3 is located at the foot of Pillar Mountain on the southwest side of the City of Kodiak. A location and vicinity map can be found in Appendix A. Originally constructed in 1972 as a 365-foot by 60-foot wide pile supported pier, Pier 3 has been upgraded several times over the last 39 years to accommodate the ever-growing cargo vessels in the shipping industry. The original section of the pier (main pier) was constructed of a concrete haunch-panel deck supported by concrete pile caps over steel H-piles and pipe piles. The main pier is fitted with a pair of parallel rail tracks which service the container crane.

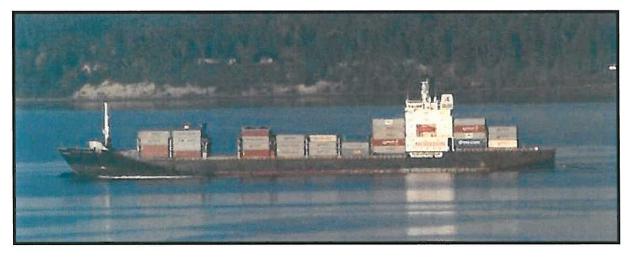
#### Figure 5: D-7 Class Container Ship

The crane and dock design will consider the current D7 class vessel that frequents the port in Kodiak as well as future ship classes. The D-7 class cargo vessel from Horizon Lines uses the existing Pier 3 dock twice a week. Specifications for the vessel are listed below (see Figure 5).

LOA:	710 feet (length overall)
LBP:	676 feet (length between perpendiculars)
Breadth (extreme):	78.21 feet
Depth (molded):	51 feet
Draft:	33.13 feet (Summer Load Line)
Displacement:	37,474 tons (Summer Load Line)
Deadweight:	20,966 tons (Summer Load Line)
Capacity:	1,668 TEU max (Twenty-foot equivalent units)
