Bethel - City Shop Floor Repairs

Remove rotted sections of City Shop floor as needed and replace with new, treated timbers and quarter-inch thick steel sheets. Replace four drains. Rebuild south ramp for trucks. Repair foundation pilings.

New City Shop Floor

FY 2013 State of Alaska Capital Budget Request

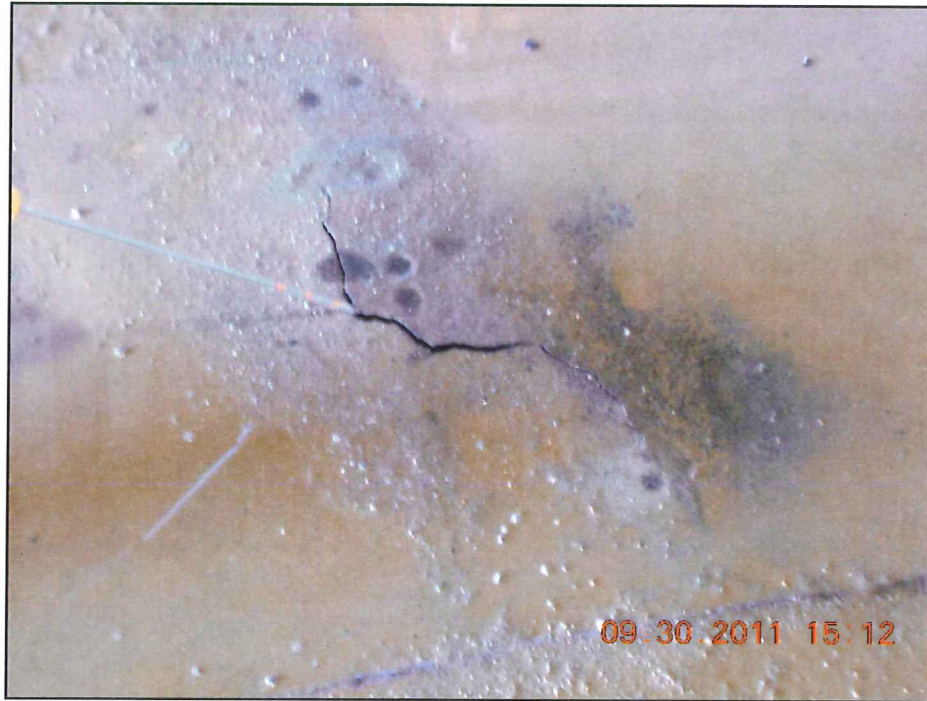
Photo
#1

Crack several inches long in 3/16" thick metal sheets on City Shop floor.

All 3/16" steel sheets and patches will be removed and 1/2" steel sheets used to replace them. The 1/2" steel sheets will be 8 ft. x 20 ft. The edges of each sheet will be beveled so that a stronger, tighter seal is achieved when welded together. The steel sheets will be angled to direct water into the center trench and down the drains to the outside of the building.

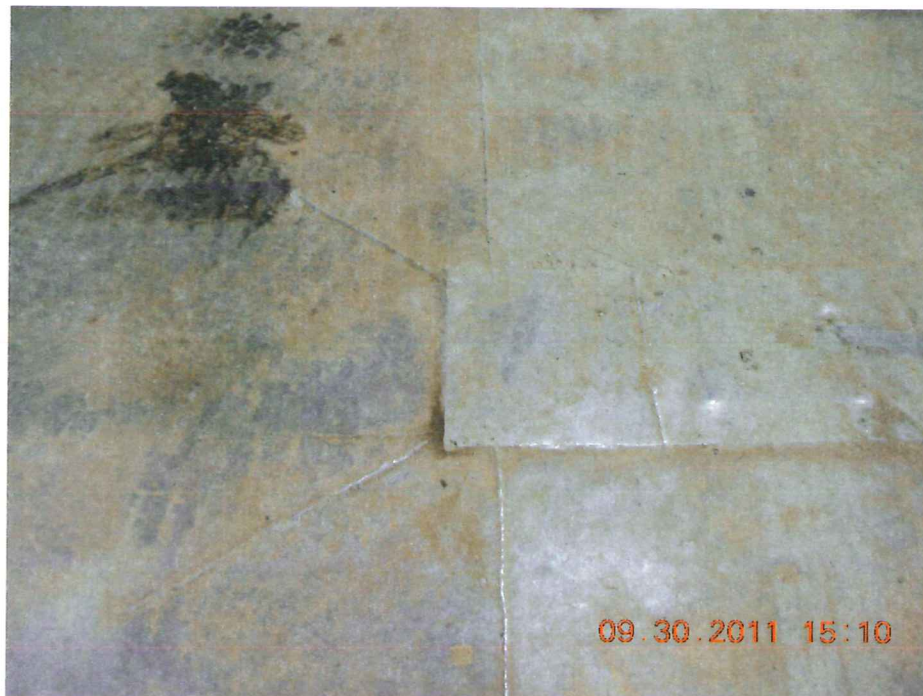
Photo
#2

Various welded metal patches on floor to stem the cracks.

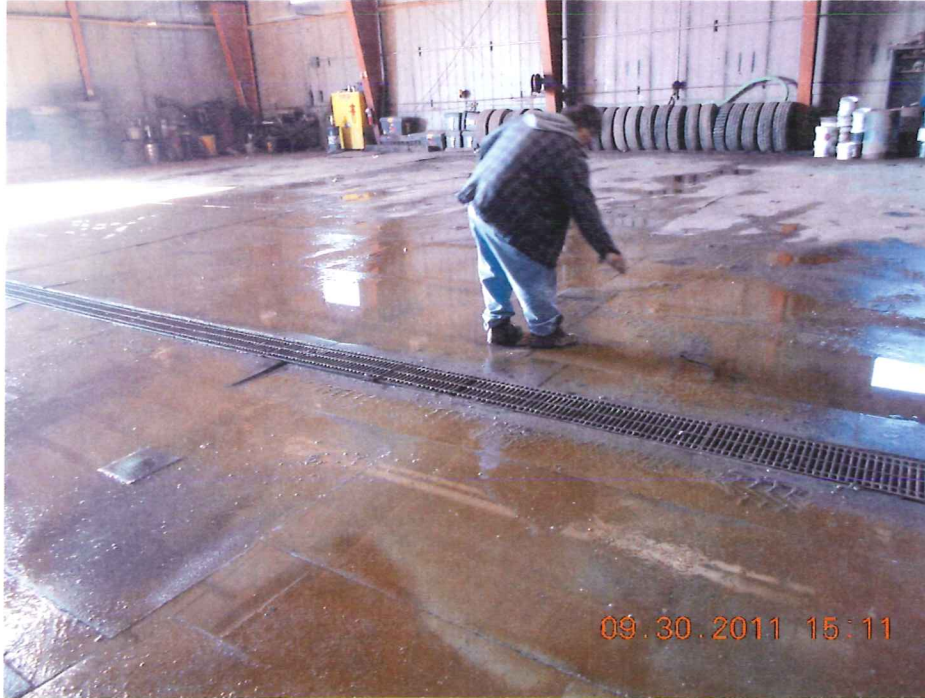
Photo
#3

Property Maintenance Foreman Clair Grifka examines floor cracks. Floors wet from continuous use of pressure washer throughout the day to wash dirt off trucks.

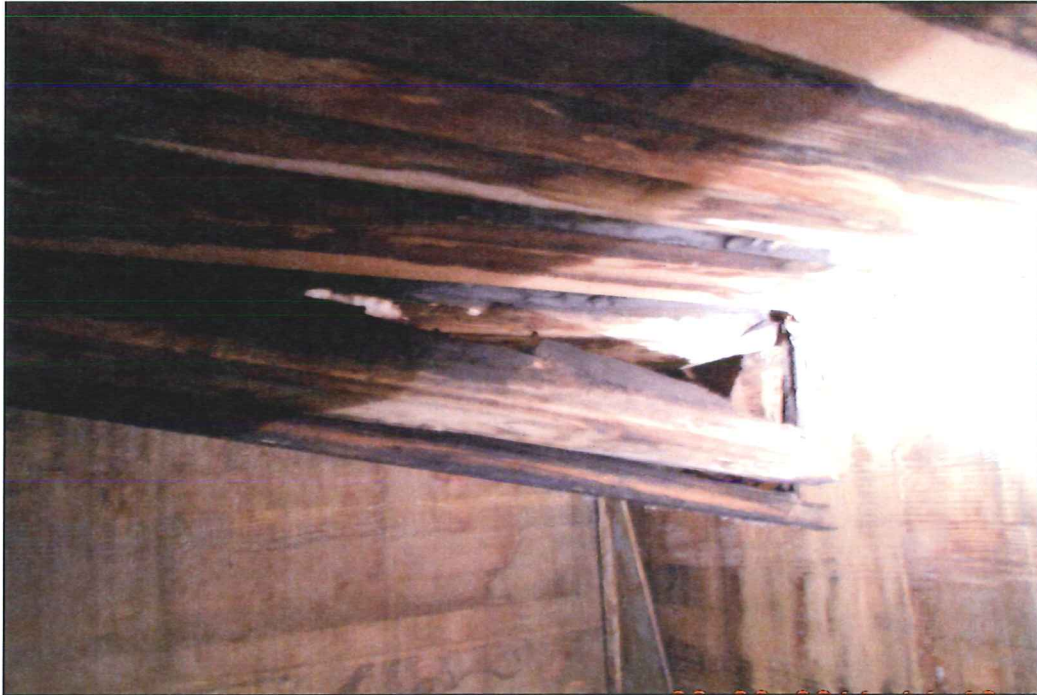
Photo
#4

Several 2 x 8s visible under building— broken and falling down from rot.

Rotted sections of 2x8s will be cut out and replaced with treated 2x8s. Rotted sections of glue-laminated beams will be cut out and repaired with treated glue-laminated beam sections. Steel brackets and bolts will be used to join the beams.

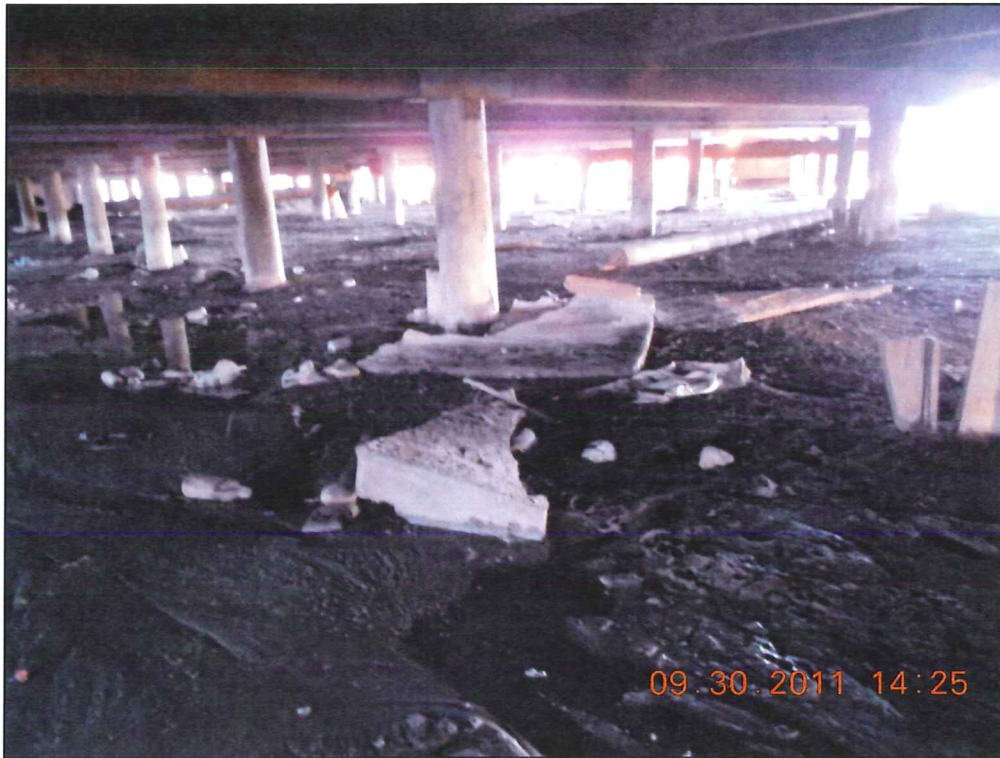
When the building was originally constructed, there was 8" thick foam sprayed under the 2x8s. Water leakage through the floor from the inside over the years saturated the foam, it turned to ice in the winter, and eventually all foam fell off. See Photo #6 attached that shows foam remnants on the ground under building.

Foam remnants are shown here on the wet sand under Public Works building. Nearly all spray foam became saturated with water, froze in winter, and dropped off.

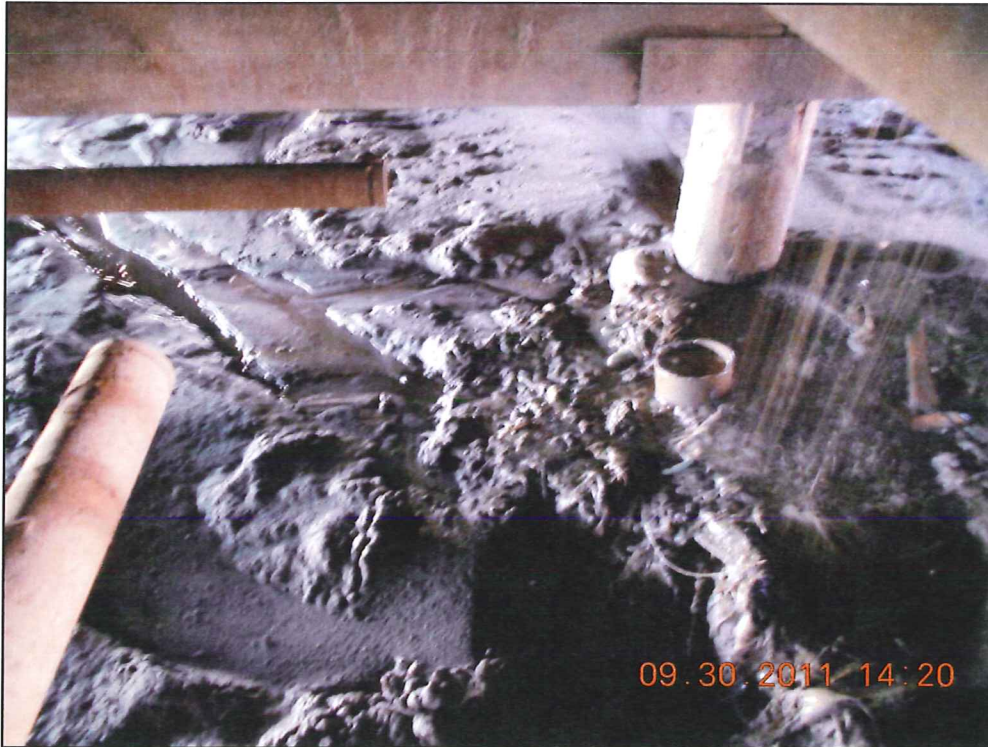
Photo
#7

Water on right of photo pours through drain hole underneath building.
Drain pipes shown disconnected.

The trench drain needs to be redesigned to function better than it does currently. Industrial drains and HDPE pipe capable of handling a large quantity of sand and debris will be purchased and installed. The end of the drain pipes will be configured so that water is diverted away from the pilings under the building.

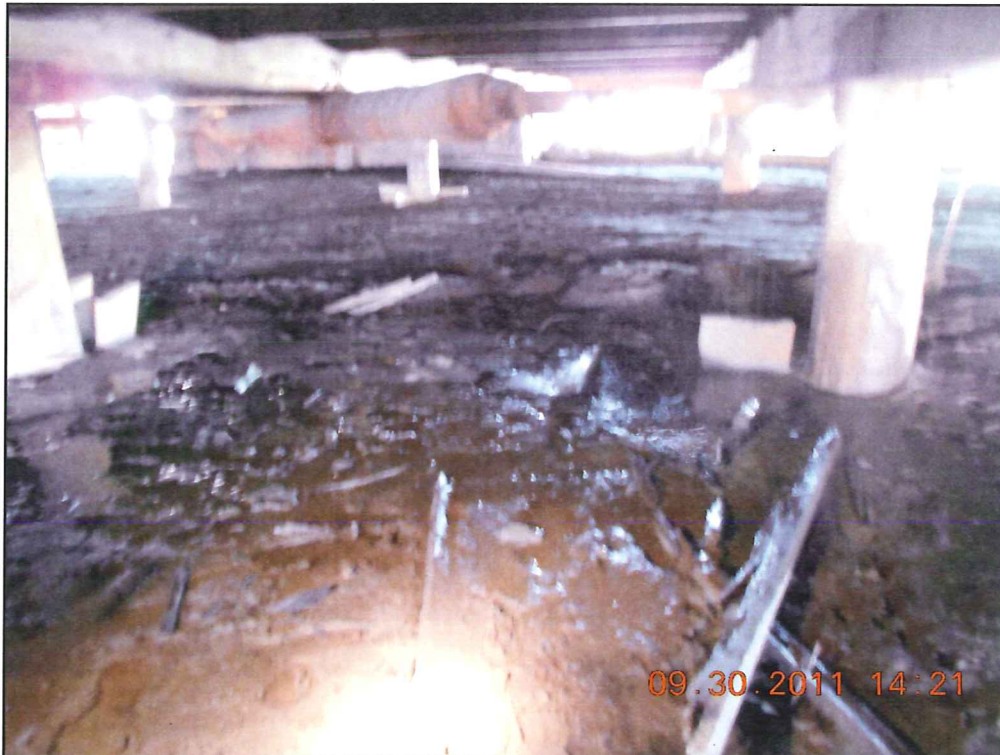
Photo
#9

Sections of 2 x 8 floor supports shown on the ground after rotting and breaking off.

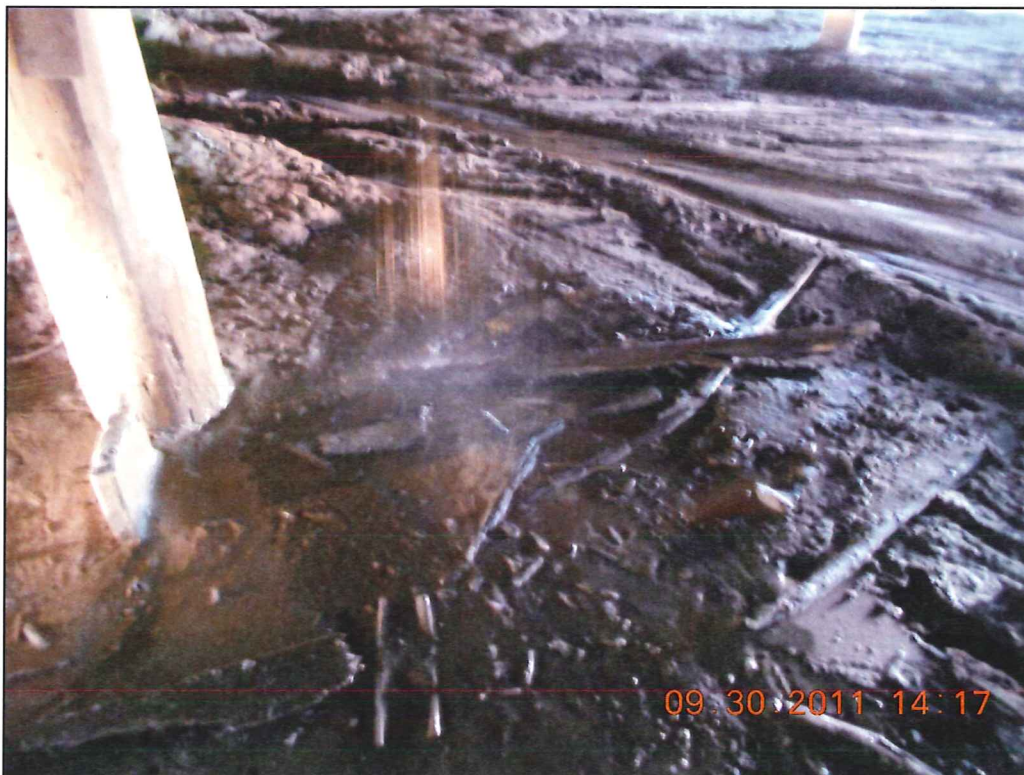
Photo
#10

Water raining down through one of four drain holes contributing to rotting floor boards.

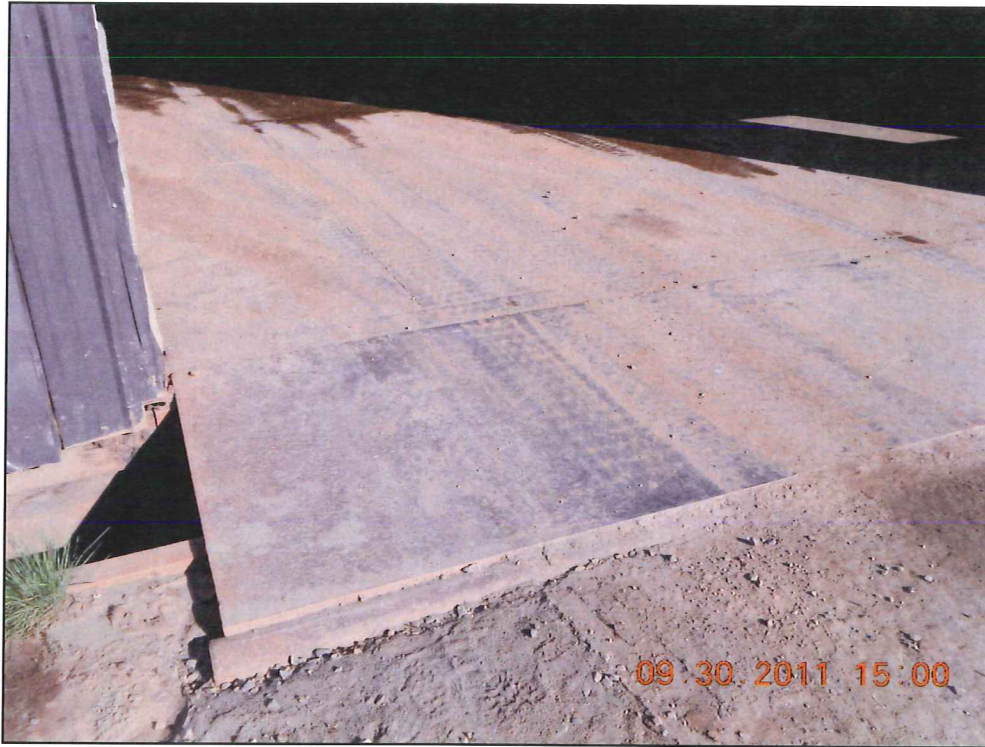
South ramp repaired in 2009 shows metal "bridge" for trucks to enter and exit garage.
Wooden ramp was separated from contact with wet dirt as part of the fix.

New pilings may be installed for the ramp or existing pilings repaired as described previously. A steel plate will act as a bridge to allow vehicles to drive from the ramp in and out of the garage. Photo #11 shows the steel plate used in the south ramp rebuild.

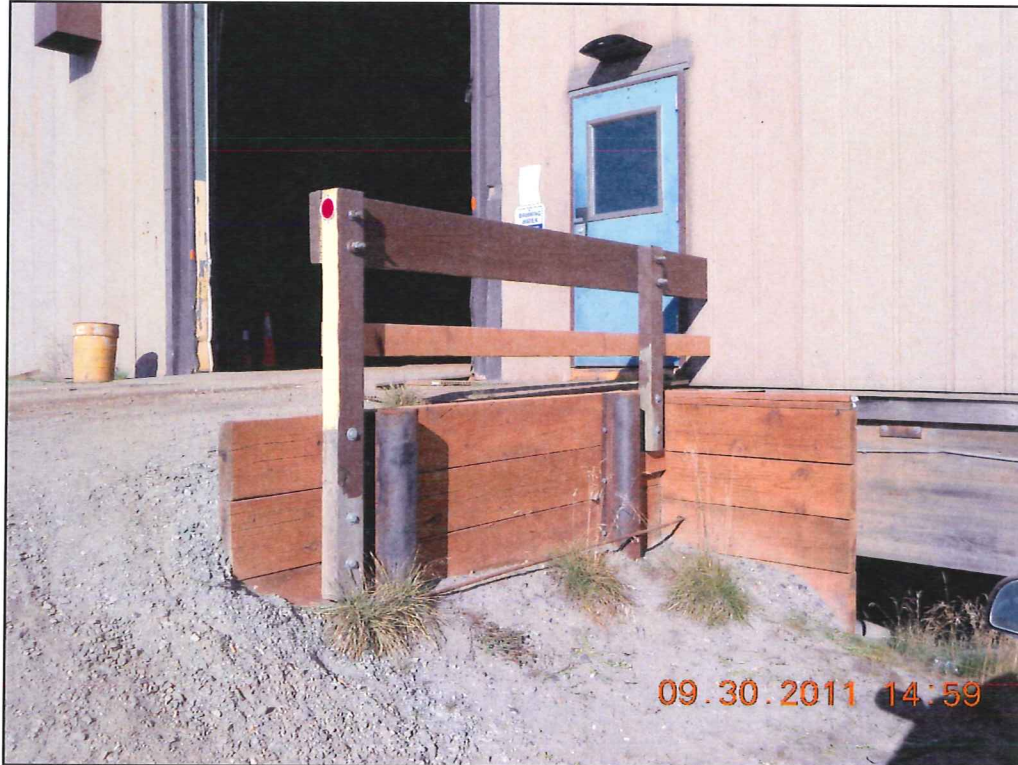
South ramp repair included construction of this bulkhead with treated wood to hold
ramp dirt in place and separate ramp from building at the same time.

The ramp will be pulled away from the building so that soil never comes in contact with the building, like it does now. A bulkhead will be constructed on both sides of the ramp to hold the dirt and gravel ramp in place. The bulkhead built in 2009 for the south ramp is shown in Photo #12 and is similar to the plan for the north ramp.
